## Run smarter buildings with the power of Gen AI

Get context, clarity and the confidence to optimize equipment operations with the "Tell Me More" feature

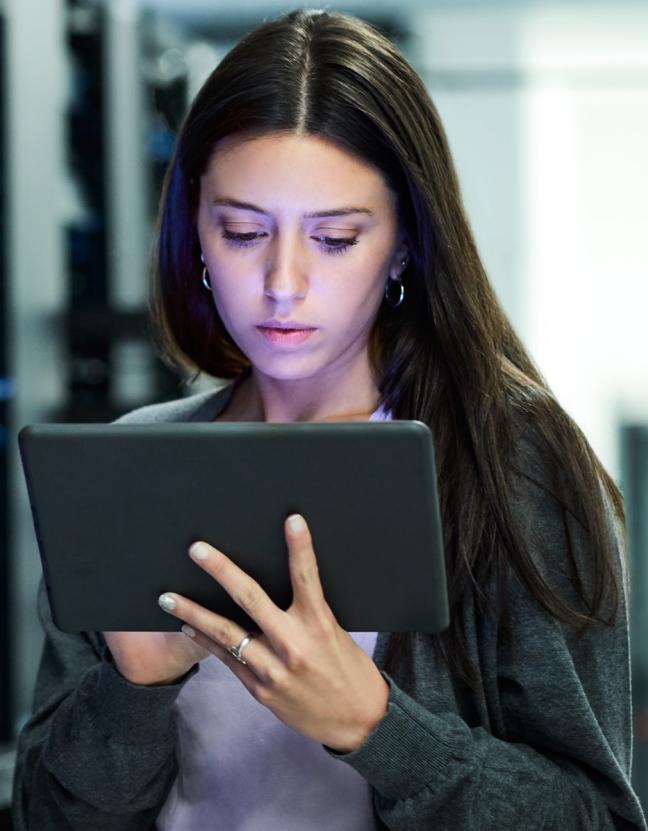
The Abound Insights Assistant App now includes "Tell Me More," a feature that provides added context to predictive insights and recommendations, when users need it. The feature combines equipment operations and maintenance learning from the Abound Insights platform with generative AI trained on technical manuals and data resources. Facility Managers and technicians get a conversational experience designed to support their workflows and help them optimize equipment operations and maintenance.
